**BAIYUN**  
Brake Expert

## BRAKE PAD TROUBLE TRACER

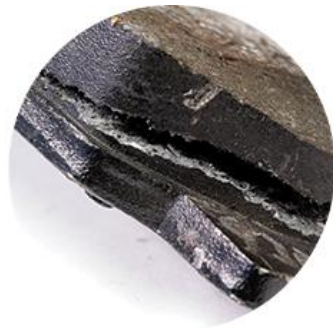
Detached friction material.

Possible excessive load or heavy braking, along with the choice of unsuitable parts.

Reduction in braking performance and typical noise (squeal) while braking.

- Replace the pads.
- Check the disc condition and minimum thickness.
- Despite having a wear indicator, it is necessary to check the pad condition every normal garage brake control visit or every six months.

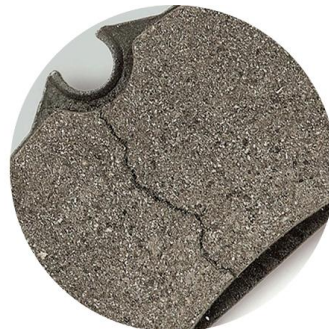
Pad with surface cracks.

Excessive load or high friction material temperature.

Possible detachment of friction material resulting in a reduction in braking performance.

- Replace the pads.
- Check for correct caliper operation.
- Check disc condition and minimum thickness.
- If necessary, replace both discs on the axle.

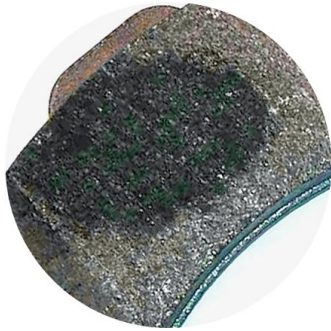
Contaminated pad friction material.

Contamination by an oily substance or solvent.

Reduction in braking performance and possible imbalance during braking.

- Replace the pads.
- Check the discs on the axle.
- Identify any fluid leaks from the hubs or other nearby components.

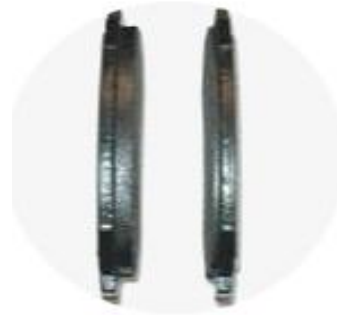
Pads on the same axle featuring uneven wear.

Incorrect return of one caliper on the same axle.

If the axle involved is the directional one, this fault may result in vehicle instability during brake release.

- Replace the pads.
- Check for the proper caliper operation.
- Check disc condition and minimum thickness.
- If necessary, replace both discs on the axle.

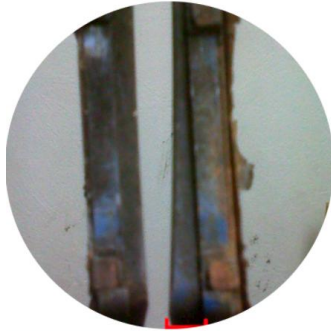
Uneven brake pad wear.

One of the calipers has become stuck or does not return correctly to the rest position.

Reduction in braking performance and possible imbalance on the involved axle, during braking.

- Replace the pads.
- Brake calipers should be checked.

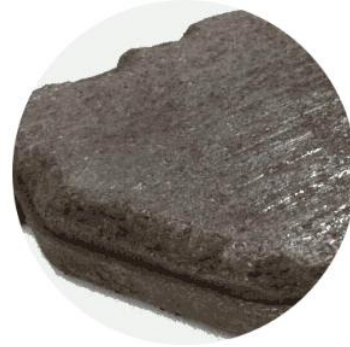
Damaged edges to the friction material (edge-crumbling).

Brake pad has become stuck in the caliper. The parts used do not comply with the correct sizes and specifications.

Early pad deterioration and uneven disc wear.

- Replace the pads.
- Check for correct caliper operation.
- Check disc condition and minimum thickness.
- If necessary, replace both discs on the axle.

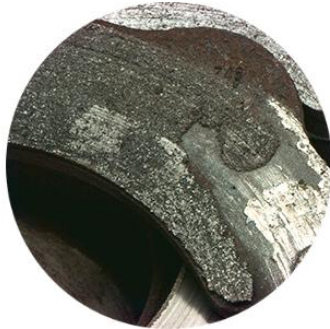
Excessively worn out discs and pads

Possible contamination of the friction material by sand, mud or earth or incomplete return of the caliper gear.

Excessive wear of one or more brake pads, resulting in damage where the pad has not been fitted with a wear indicator.

- Replace the pads.
- Check disc condition and minimum thickness.
- If necessary, replace both discs on the axle.

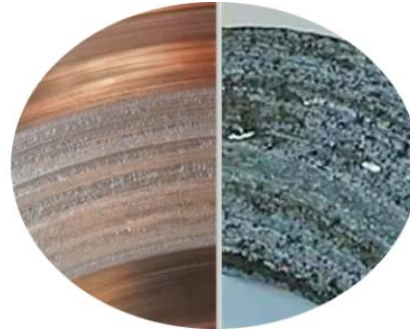
Friction includes metal pick-up.

High temperature generated between brake pad and disc in wet conditions.

Wear of the affected brake disc with typical metal rubbing noise during braking.

- Replace the pads.
- Check disc condition and minimum thickness.
- If necessary, replace both discs on the axle.
